# 16<sup>TH</sup> AUSTRALASIAN TUNNELLING CONFERENCE 2017

# Nightcap WTP Outlet Tunnel Rehabilitate or Replace?

DD O'Connor<sup>1</sup>, SR Macklin<sup>2</sup>

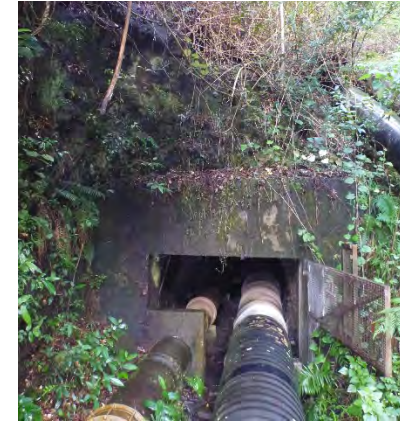
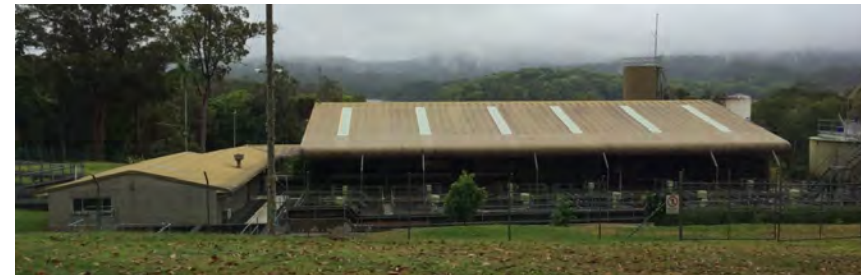
- Owner – Rous County Council
- Rous County Council is the regional water supply authority of Northern Rivers region of NSW.
- Nightcap Water Treatment Plant provides approximately 90% of the water.
- Bulk water passes through a DN 750 cement lined mild steel pipe, located within the unlined Outlet Tunnel.

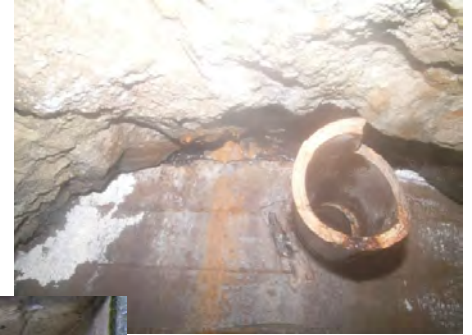
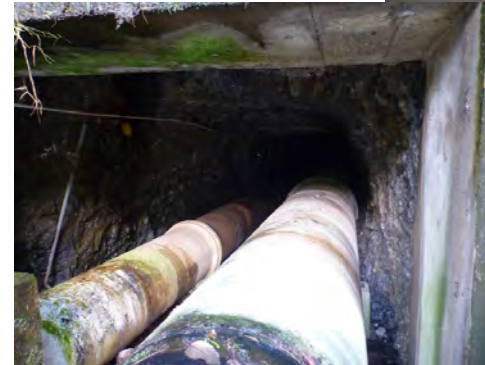
- 2013 safety concerns raised regarding leaks around the mass concrete tunnel plug.
- Inspection of the tunnel considered that risks to the tunnel, water transfer pipes and plug were high.

- A DN 150 ventilation pipe of unknown material/condition that penetrates the plug.

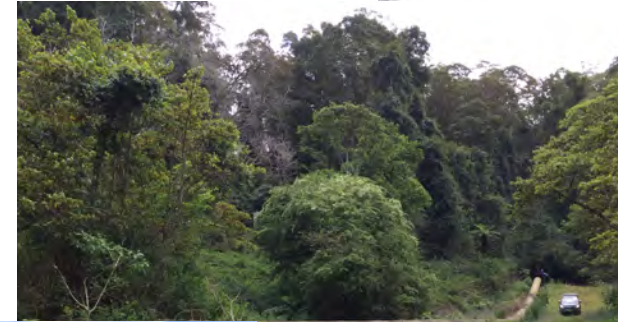
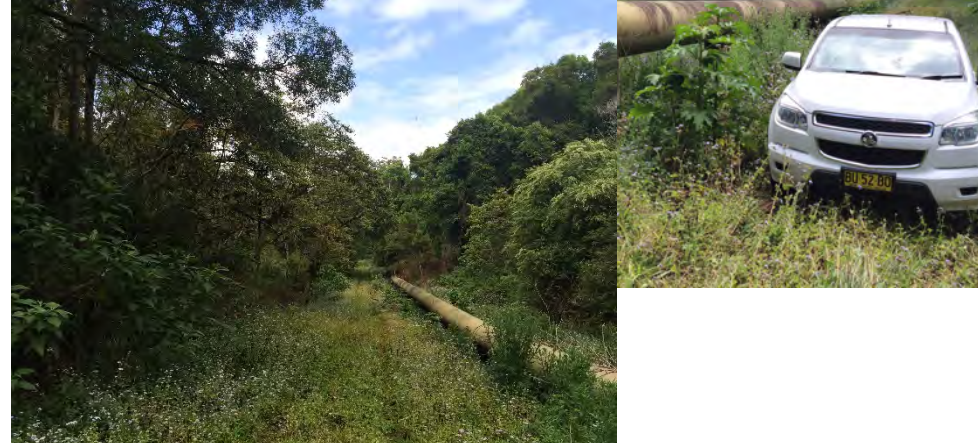
1. The trackway was in poor condition
2. Necessary to upgrade the access track for significant works at the southern portal.
3. Crossed private land with a risk that access could be restricted.

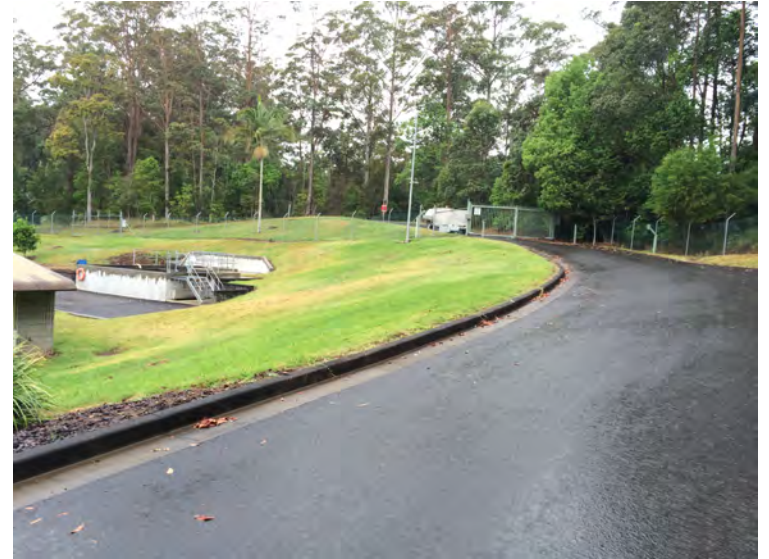
1. Any outage of greater than 24 hrs would be catastrophic to Rous
2. DN 750 pipe and the tunnel had to remain in almost continual operation
3. Surface bypass pumping expensive and would result in a pipe that would pass under/over the only entrance to the water treatment plant.

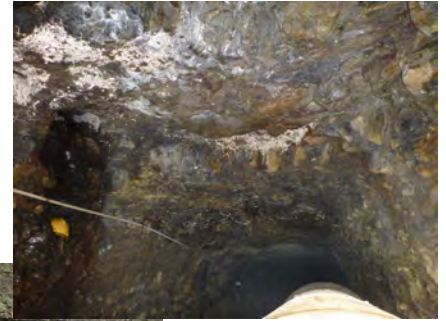
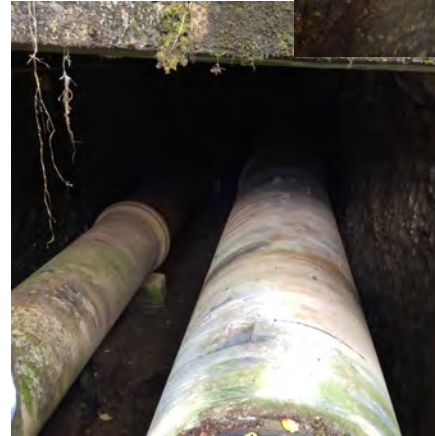
## Unsupported ground in existing tunnels:

The combination of risks indicated that rehabilitation works within the tunnel would present an unreasonable level of risk to personnel and the water supply

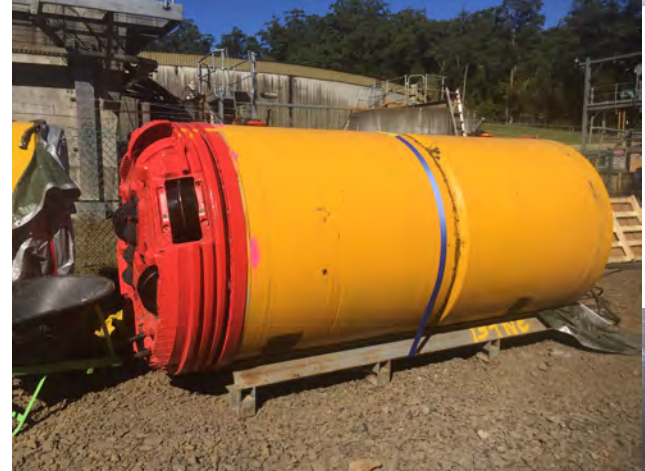
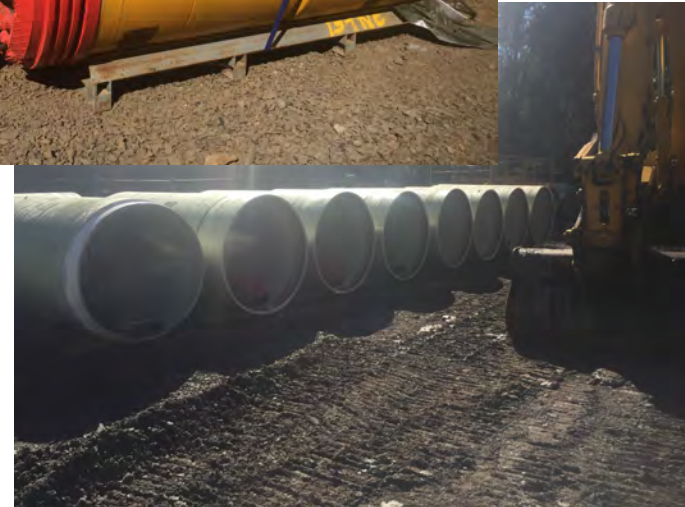
- First:  
Permanent duplication of the water transfer system (pipe jacking).
- Second:  
New tunnel plug from an adit  
(Conventional)

Pipe jack is complete; New tunnel plug due to begin shortly.
